Property Inventory and Condition Survey

for the Group IV Utility Systems Property Group II Chemical Plant Property within the Shell Oil Company Leasehold Area **US Army Rocky Mountain Arsenal**

GROUP IV UTILITY SYSTEMS PROPERTY Remaining Group IV Properties and Utility Systems

27 September 1982

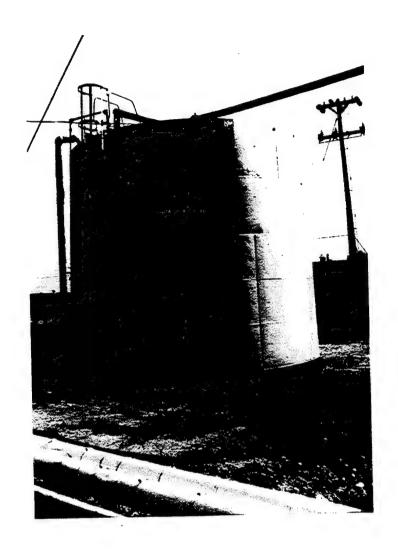
BUILDING NO. 321A (TANK): General View

Exterior. (Looking East)
Date of Photograph: 30 August 1982

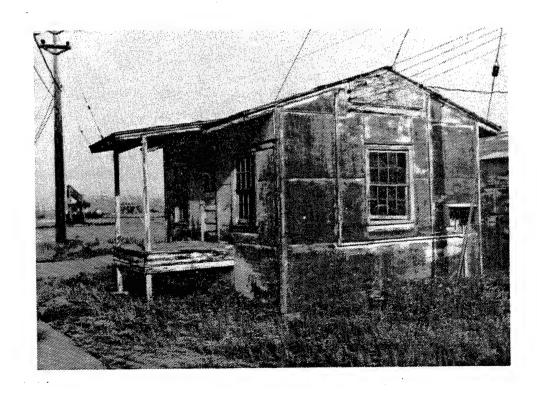
BUILDING NO. 322: General View Exterior.

- 3.00 PRESENT CONDITION. Building No. 322 is in generally fair (F) condition. The estimated remaining useful life of this building from August 1982, with minimum maintenance and no building use change, is 8 years.
 - .10 Exterior: Building No. 322.

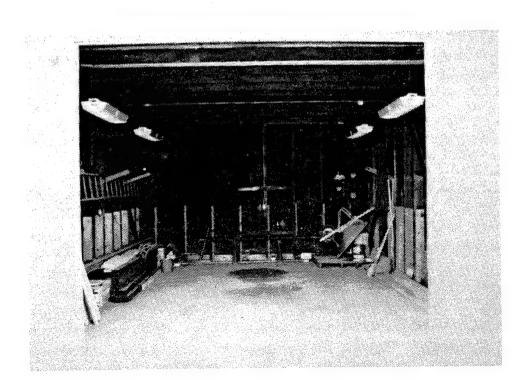
BUILDING NO. 322A: General View.

3.00 PRESENT CONDITION. Building No. 322A is in a fair (F) condition. the estimated useful life of this building as of August 1982, with minimum maintenance and no building use change, is 10 years.

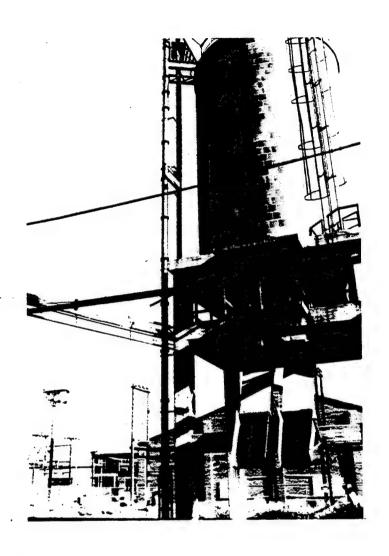
BUILDING NO. 323: Ash Handling

3.00 PRESENT CONDITION. The hopper structure is in good condition (G), but is probably not operational without major work on the equipment. The estimated useful life of the structure as of August 1982, with minimum maintenance and no building use change, is 25 years. (Structure has not been used in many years.)

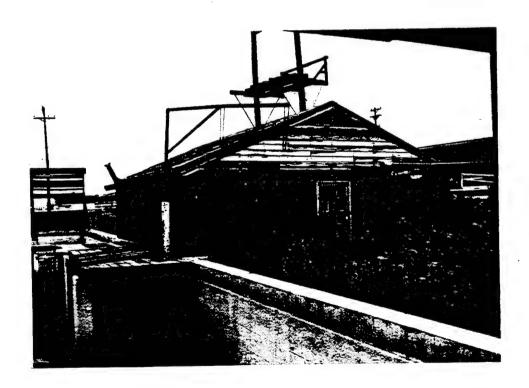
BUILDING NO. 326: General View of

3.00 PRESENT CONDITION. The spray pond louvers are in poor (P) condition and the concrete floor is badly cracked. The piping is in poor condition and has been disconnected (P). The pump house is in fair (F) condition. The estimated useful life of the building from August 1982, with minimum maintenance and no building use change is 10 years.

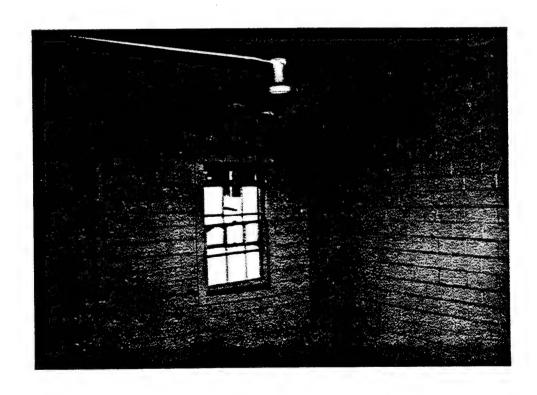
BUILDING NO. 337: Interior.

3.00 PRESENT CONDITION. The building is in fair (F) condition. The estimated remaining useful life as of August 1982, with minmum maintenance and no building use change, is 8 years.

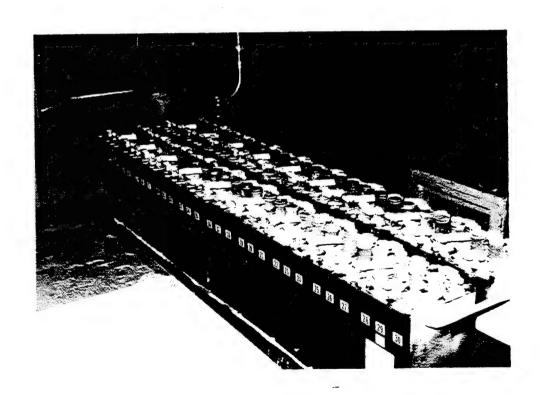
BUILDING NO. 361: Sixty (60) Lead Calcium Batteries (Replacement) Date of Photograph: 26 August 1982

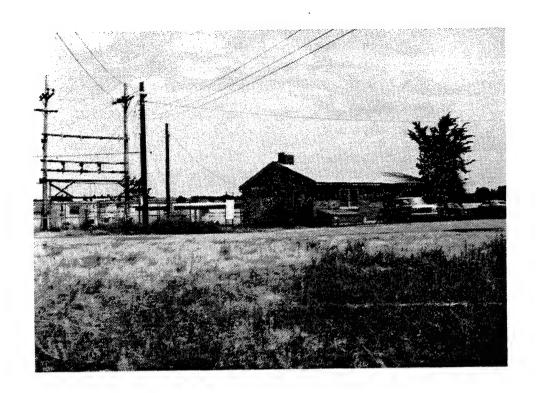
BUILDING NO. 371: General View (Looking

East)

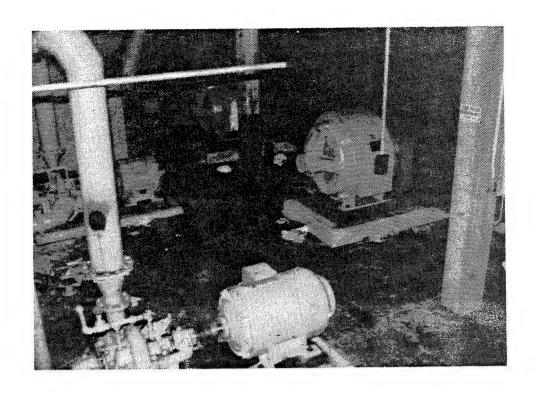
BUILDING NO. 371: Pump Date of Photograph: 30 August 1982

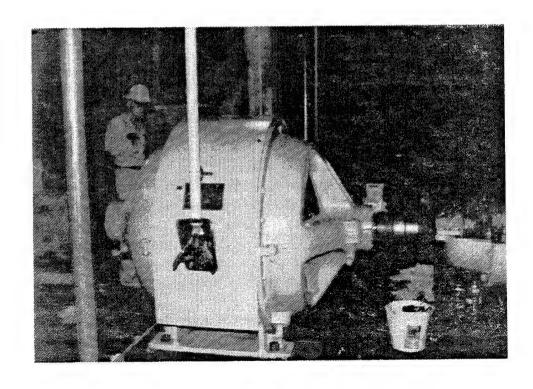
BUILDING NO. 371: Basement (Looking

from Stairs)

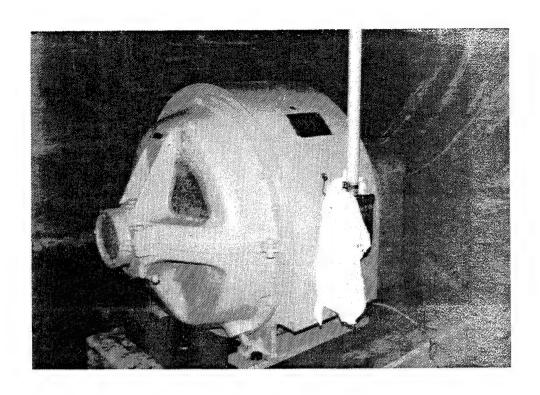
BUILDING NO. 371: Basement. Motor Date of Photograph: 30 August 1982

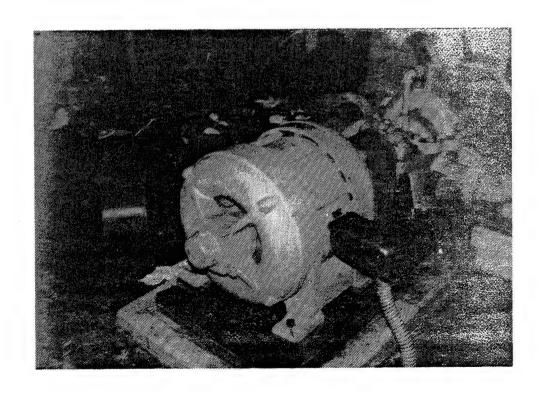
BUILDING NO. 371: Basement. Motor Date of Photograph: 7 September 1982

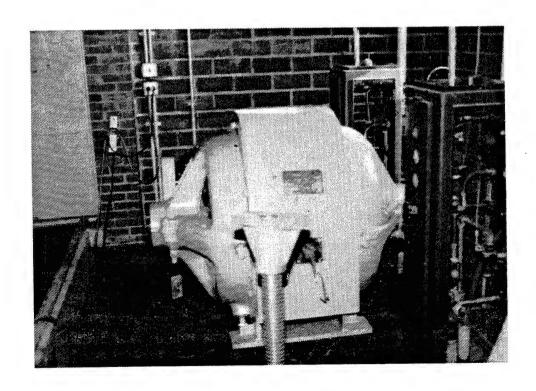
BUILDING NO. 371: Chlorination

Room (Looking South)

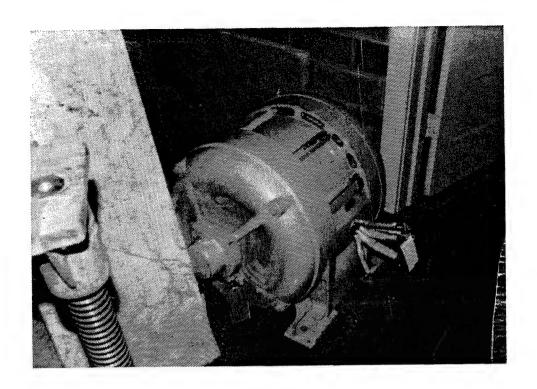
BUILDING NO. 371: Motor (Not Installed Stored in Chlorination Room Date of Photograph: 7 September 1982

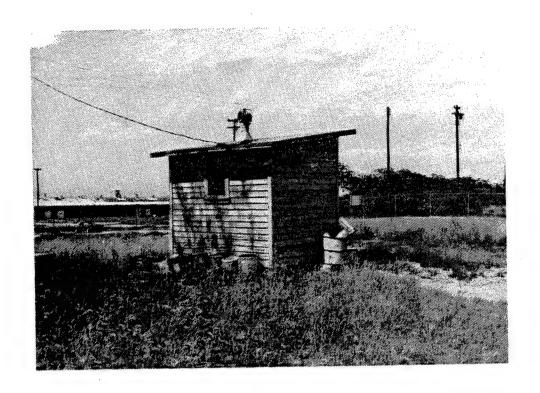
3.00 PRESENT CONDITION. The building is in fair (F) condition, but the equipment is badly corroded. The estimated remaining useful life of this building as of August 1982, with minimum maintenance and no building use change, is 10 years.

BUILDING NO. 378: Exterior
Date of Photograph: 26 August 1982

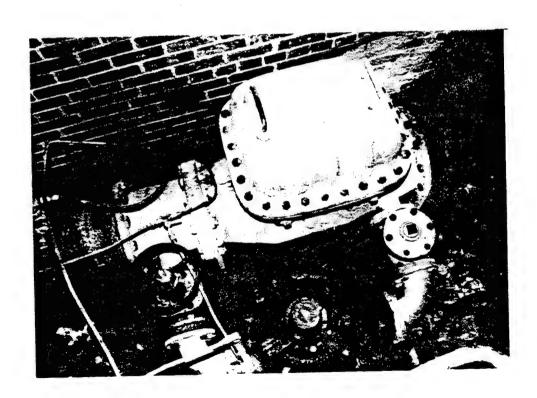
BUILDING NO. 378: Hersey Detector

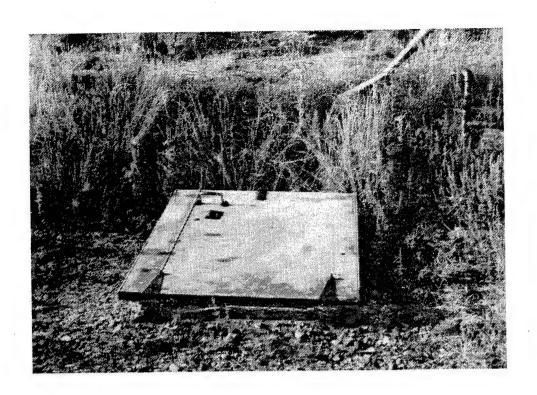
There is no foundation. The building has a gravel floor and concrete roof and brick walls. This is a standby chlorinator station and the piping is badly corroded on the exterior. Externally the meters appear in good condition (little corrosion), however, there is no way of determining if there is any internal corrosion. This facility is not currently operational; chlorinator pumps have been removed.

BUILDING NO. 382: Exterior

(Looking South)

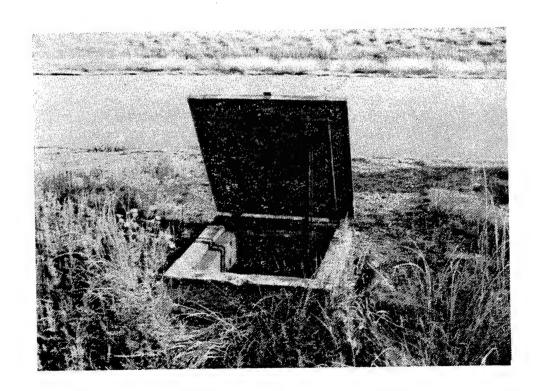
BUILDING NO. 382: Exterior

(Looking North)

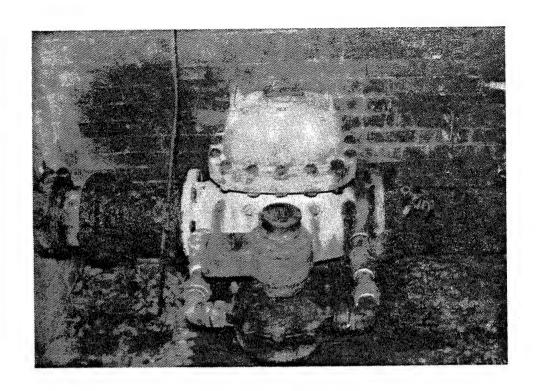
BUILDING NO. 382: Interior

Adjusto Feeder

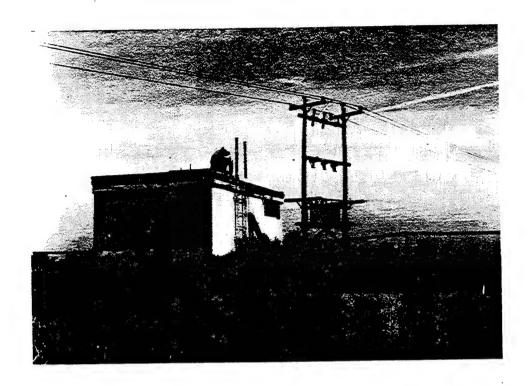
3.00 PRESENT CONDITION. Building No. 385 is in good (G) condition.

BUILDING NO. 385 (WELL NO. 1): General View of Pump House. (Looking Northwest) Date of Photograph: 30 August 1982

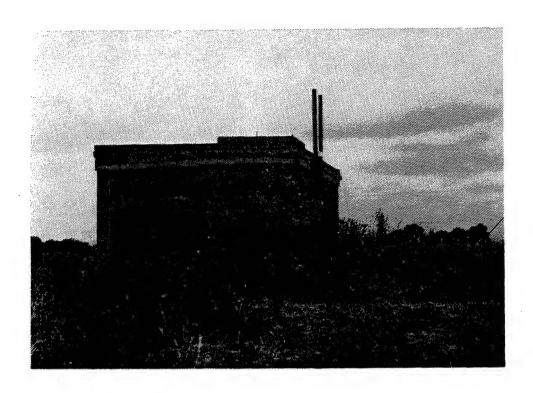
3.00 PRESENT CONDITION. Building No. 386 is in good (G) condition.

BUILDING NO. 386 (WELL NO. 2): General View of Pump House. (Looking Southwest) Date of Photograph: 30 August 1982

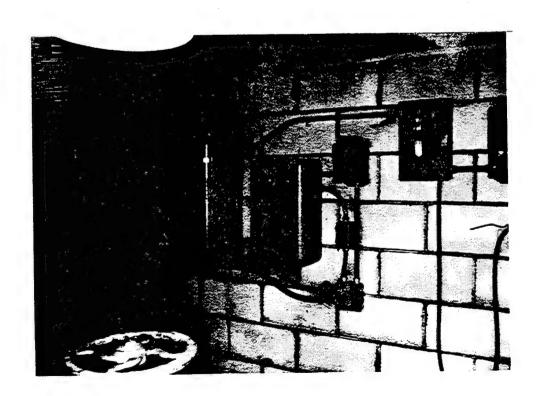
BUILDING NO. 387: Interior Controls Date of Photograph: 30 August 1982

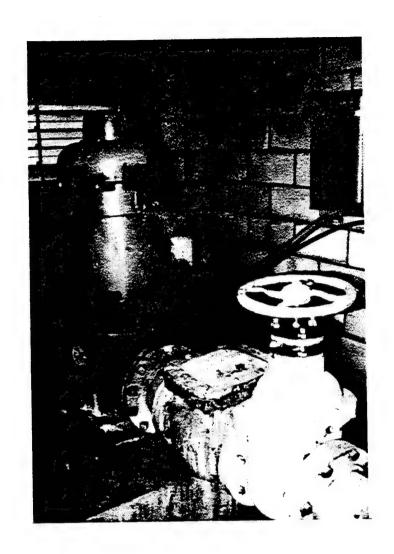
BUILDING NO. 387: Interior Pumps
Date of Photograph: 30 August 1982

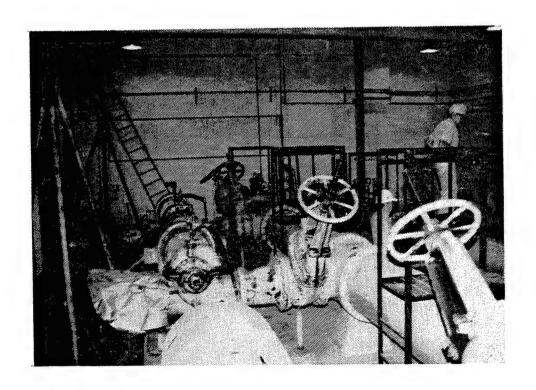
BUILDING NO. 548: Pump Room. General

View (Looking East)
Date of Photograph: 31 August 1982

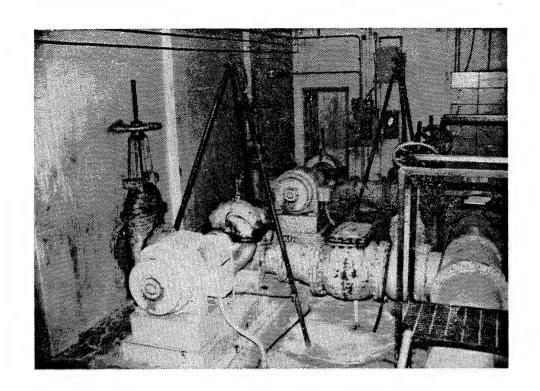
BUILDING NO. 548: Pump Room. General

View. (Looking West)
Date of Photograph: 31 August 1982

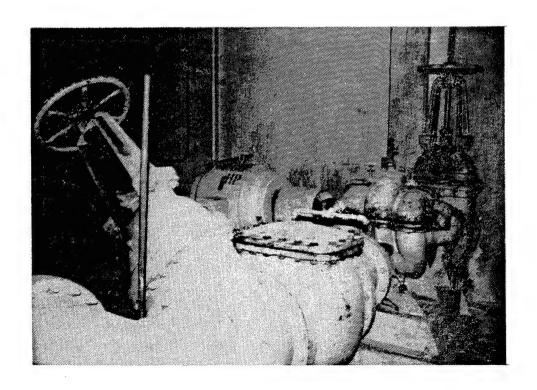
BUILDING NO. 548: Pump Room. Suction

Pumps and Header.

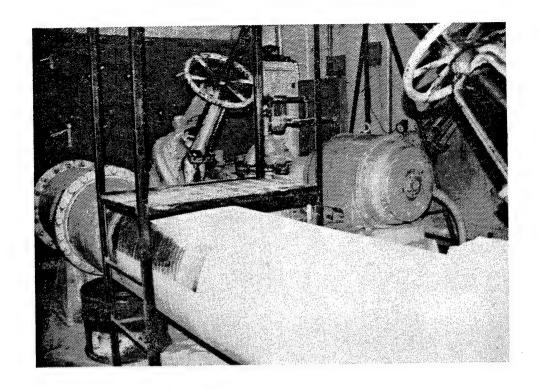
BUILDING NO. 548: Pump Room. Discharge

Pumps and Headers.

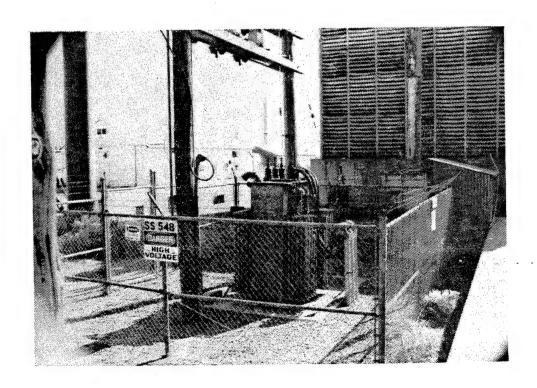
BUILDING NO. 548: Transformer,

Electrical Substation

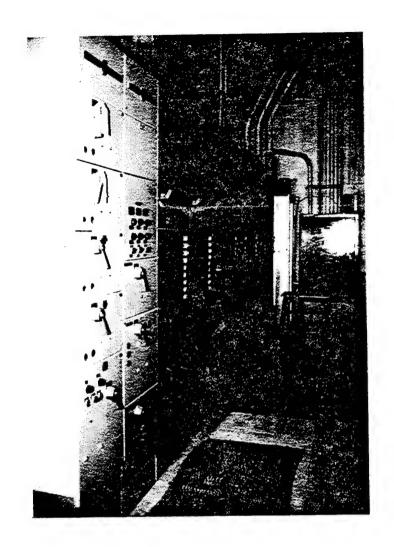
BUILDING NO. 548: Pump Room.
Control Panel
Date of Photograph: 31 August 1982

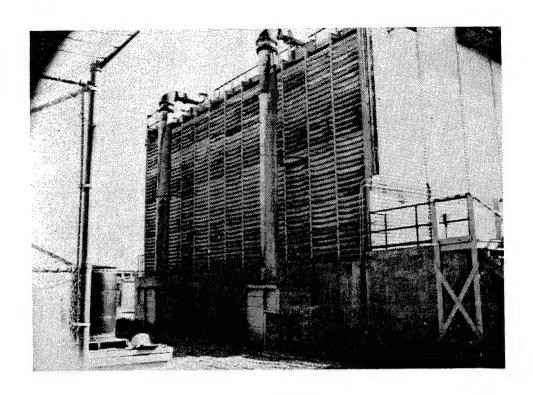
BUILDING NO. 549: Cooling Tower (West Side)
Date of Photograph: 31 August 1982

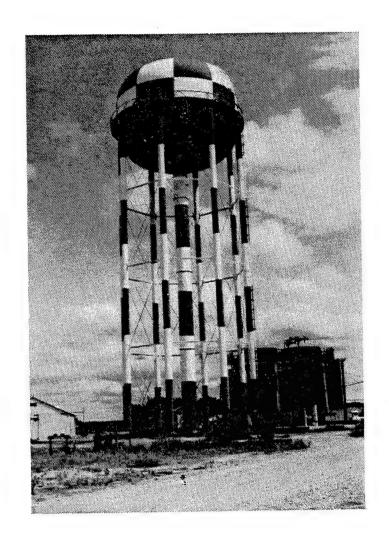
ELEVATED WATER TANK - NP

- 2.00 DESCRIPTION OF BUILDING/FACILITY. Cooled water from the cooling tower (#549) is stored in this tank. It is 150' high (Above the ground) and is of all steel construction, capacity 500,000 gallons. The supporting piers and footings are reinforced concrete. There are no fire protection facilities. The tank is supplied with steam heating coils. It was repainted in August 1976.
- 3.00 PRESENT CONDITION. Facility No. 551 is in good (G) condition. The estimated remaining useful life of the tank from August 1982, with minimum maintenance and no change in use, is 20 years.
- 4.00 RECORD OF INSTALLED EQUIPMENT. There is no installed equipment.

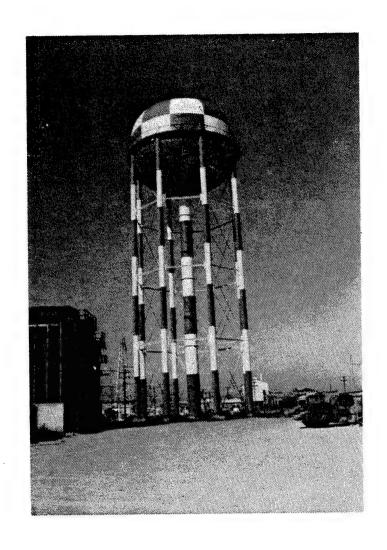
BUILDING NO. 551: Elevated Water Tower Date of Photograph: 31 August 1982

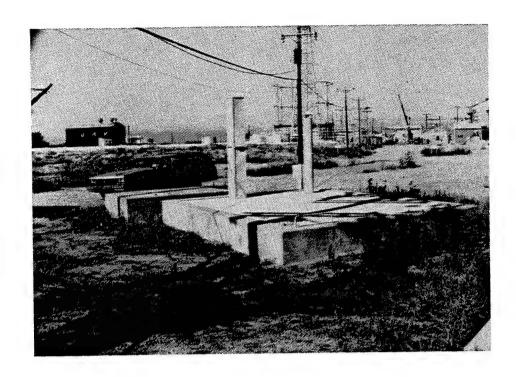
BUILDING NO. 552: Valve Pit. Exterior.

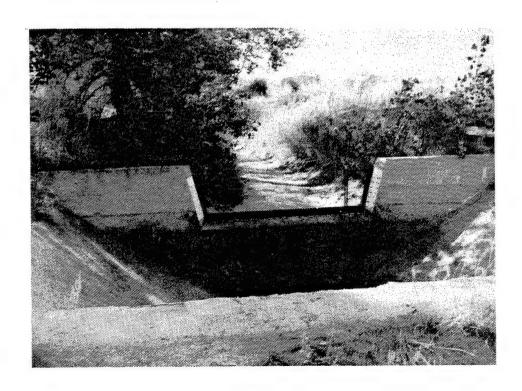
HIGHLINE CANAL: Diversion Control

Channe 1

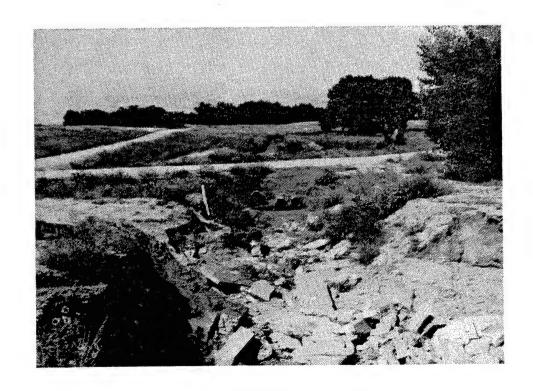
MEASURING STATION: South of 6th

Avenue (Looking South)
Date of Photograph: 3 September 1982

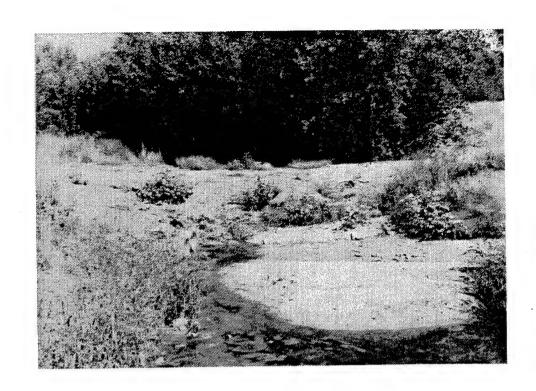
DIVERSION STRUCTURE FROM HIGHLINE CANAL (Erosion) (Looking East)
Date of Photograph: 3 September 1982

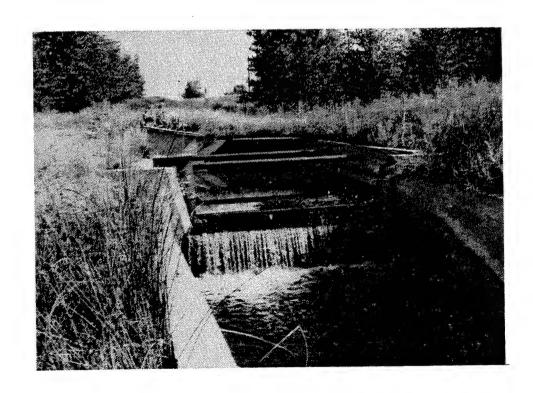
MONTBELLO CANAL: Block and Diversion To Lower Derby Lake

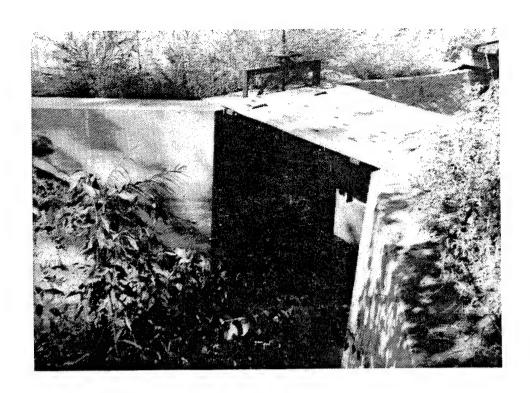
DIVERSION CHANNEL FROM UPPER
DERBY OUTFALL TO LADORA LAKE
Date of Photograph: 3 September 1982

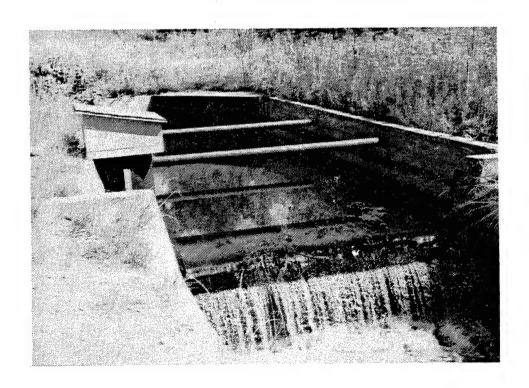
Diversion Box from Upper Derby Date of Photograph: 7 September 1982

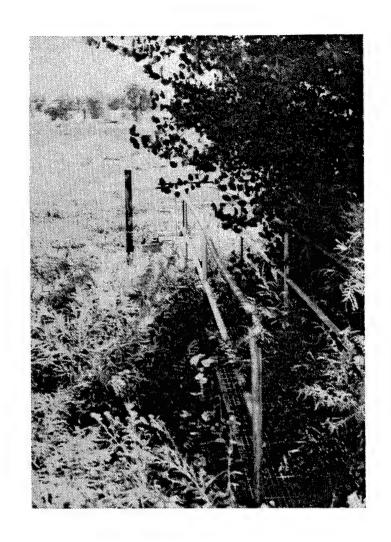
DERBY LAKE: Looking North
Date of Photograph: 26 August 1982

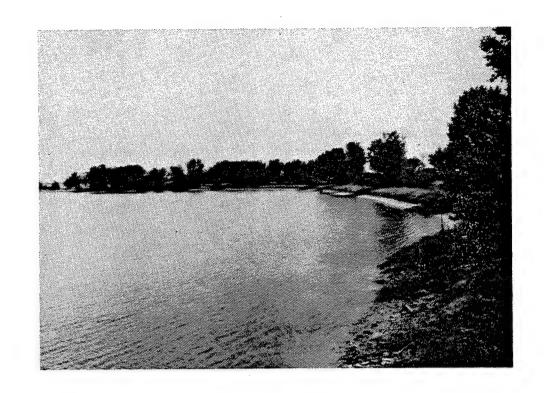
UPPER DERBY LAKE AND OUTFALL STRUCTURE (Abandoned)
Date of Photograph: 3 September 1982

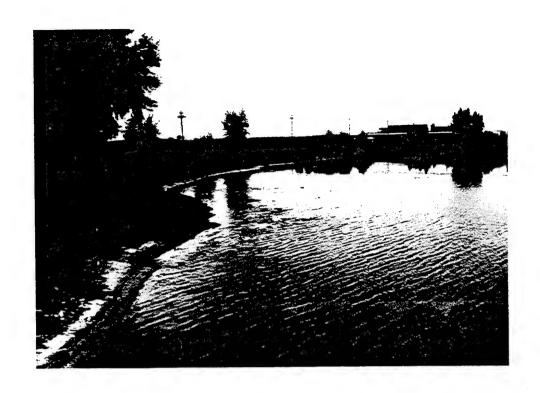
LOWER DERBY LAKE: Dike and Riprap.

(Looking South)

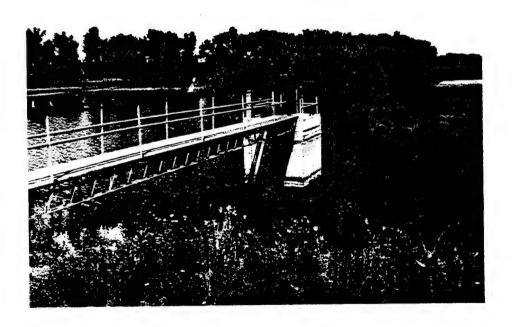
LOWER DERBY LAKE: General View

(Looking Southeast)
Date of Photograph: 26 August 1982

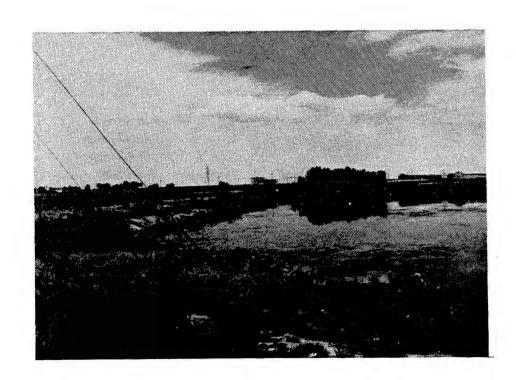
LADORA LAKE DIKE AND RIPRAP: Looking South at West Side Date of Photograph: 26 August 1982

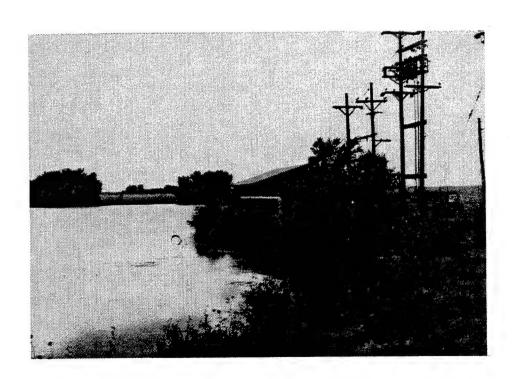
LADORA LAKE DIKE: Looking North

at West Side

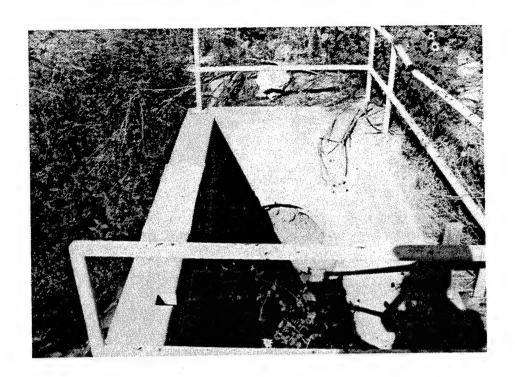
FACILITY NO. 550: Lift Station

(Near Building No. 548)
Date of Photograph: 14 September 1982

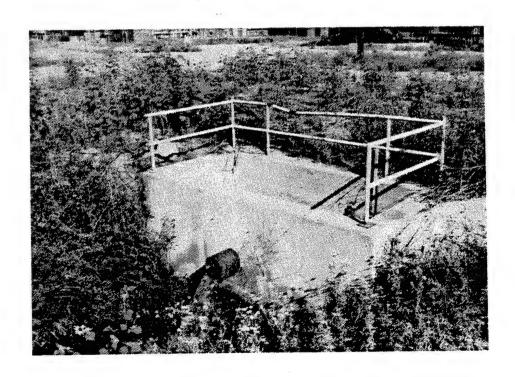
CONCRETE COLLECTING BOX: General View (Near Building No. 548)
Date of Photograph: 31 August 1982

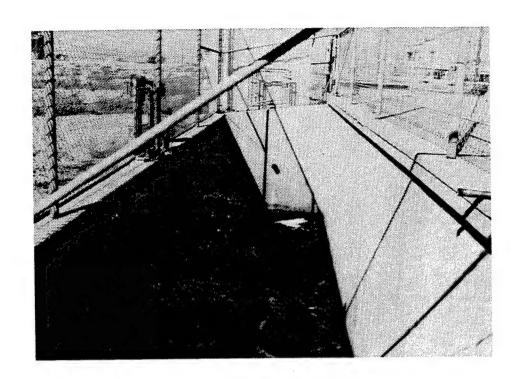
CONCRETE COLLECTING BOX: General View

(Near Building No. 548)

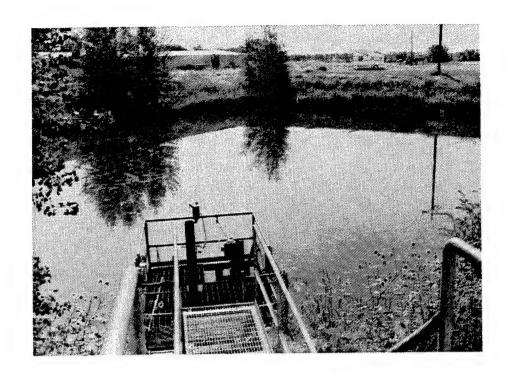
WET WELL: Adjacent to Pump Room (Building No. 548)
Date of Photograph: 31 August 1982
